New Car RFI? Buyer Beware

That shiny new car may not be quite the mobile platform you were hoping for.

John Perone, W8RXX

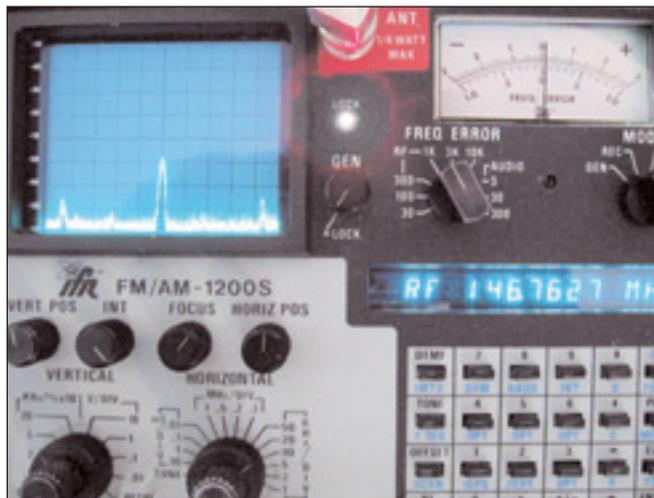
Figure 1 shows the offending signal at 146.7627 MHz 30 dB above the noise. The signal was picked up by a 2 meter flexible antenna connected to the spectrum analyzer and lying on the dash where the measurement was taken.

Figure 1 — The offending signal at 146.7627 MHz 30 dB above the noise.

After speaking to factory tech reps and much online research, interesting things were discovered. Three CPUs in the car operate at different clock speeds and are multiplexed onto a data bus. Two of the CPUs are attached directly to the back of the fuse panels located in the panels by our feet. This makes it impossible to place toroids or other filters on them. The third is located beside the battery under the hood. A product of this multiplexed bus is generating the RFI signal. The good old days of simple cars are gone.

How did I solve the problem? I got rid of the car. I must give credit to my local dealership. They allowed me to trade for a

different vehicle without taking a loss. I guess this is why we have bought three cars from them in the past. Interestingly, the replacement car generates a signal on 146.785 MHz. Since this is not a local repeater frequency, it is not an issue for us.
